***EVALUATION OF
SECURING PROCEDURES FOR
MOBILE OFFSHORE DRILLING UNITS
WHEN THREATENED BY HURRICANES***

Final Report

(REPORT NO. H3348/NDAI/CAC)

February 9, 1995
Job No. 93625

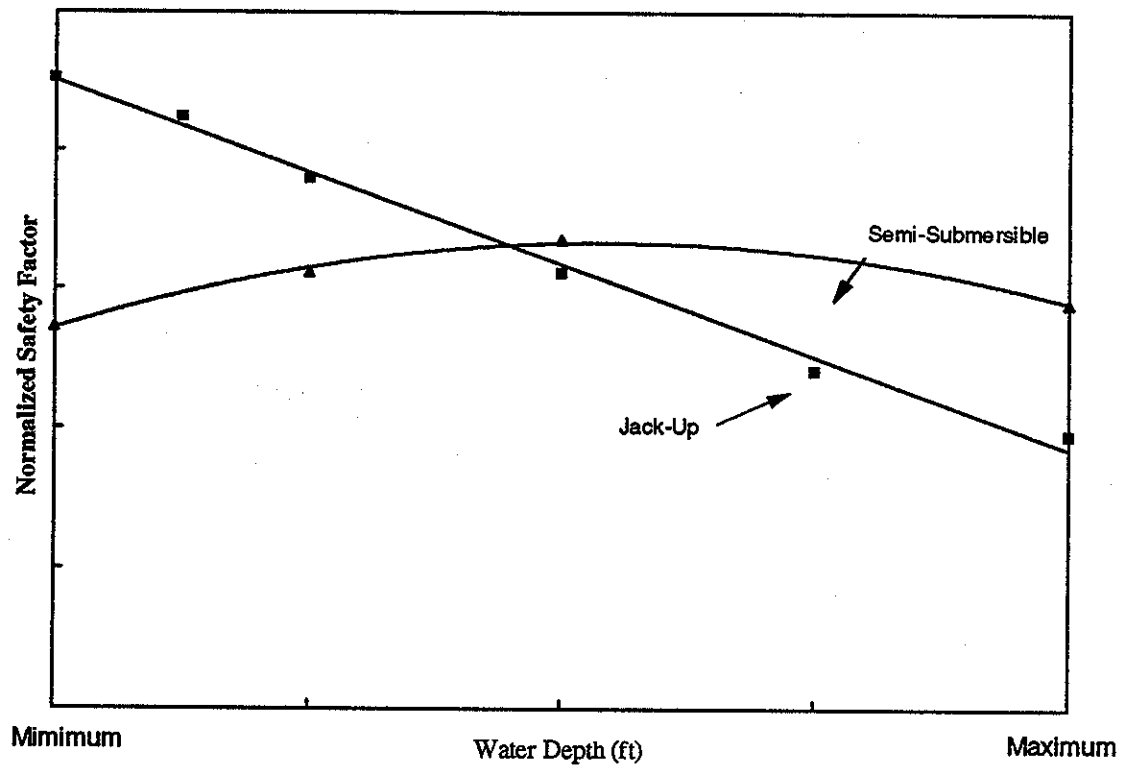
Figure 6.1 Comparison of Relative Performance for a Semi-Submersible and Jack-Up

jack-ups. Figure 6.1 is a plot of the overturning safety factor for a common jack-up against the mooring line failure safety factor for a semi-submersible. The scales have been modified to allow both to fit on the same axes, so absolute safety factors have no meaning: the importance is the slope of the line. It can be seen that while the safety factor for the semi-submersible has a minimum in both deep and shallow water conditions, the jack-up consistently gets worse as the water depth increases.
